LANL experience with the Canberra NetCAM

**Presented at 22nd Annual Air Monitoring
Users Group Meeting, Las Vegas, NV**

Tom McLean, Tom Voss, Al Justus and James Bland

Los Alamos National Laboratory

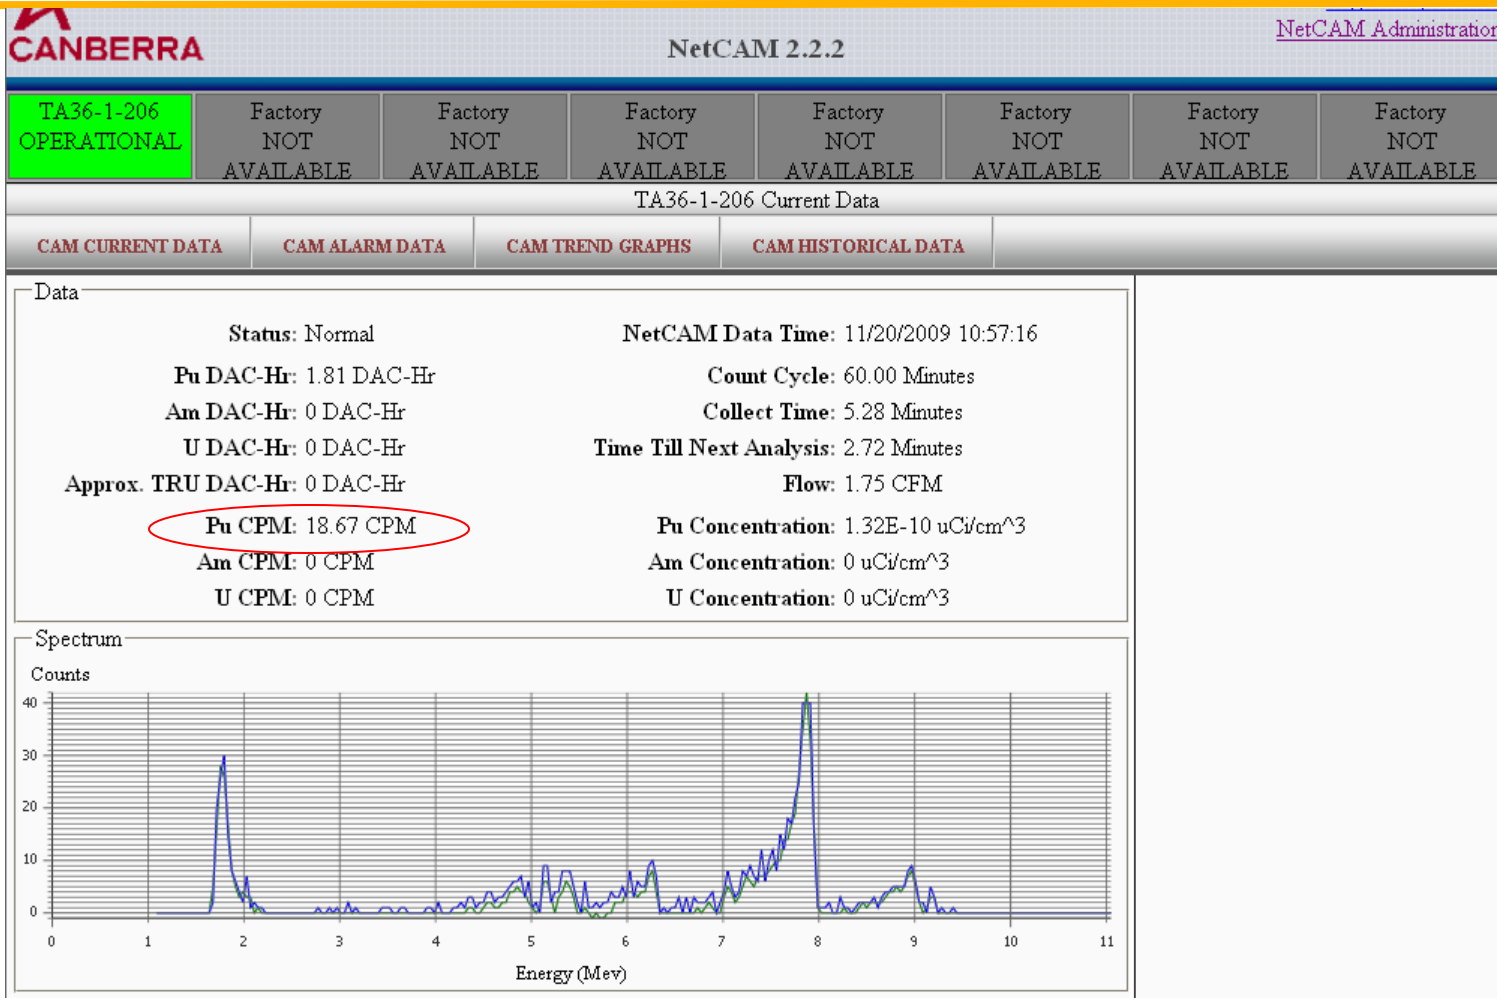
Valley mode: 75 dpm ^{239}Pu source after 4 minutes

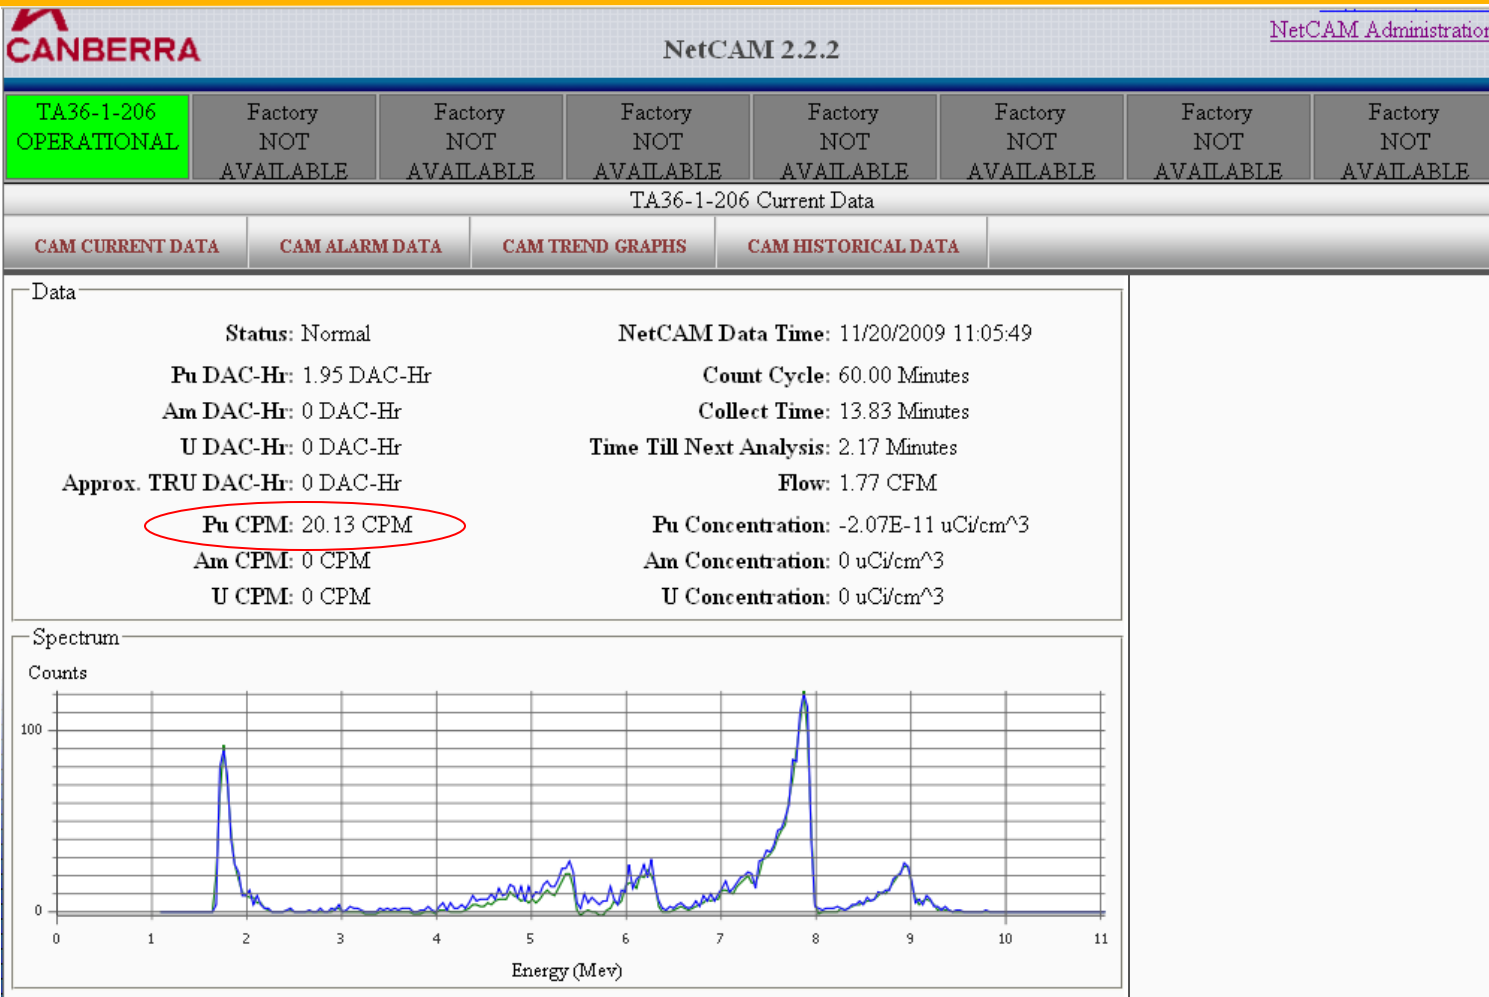
Valley mode: 75 dpm ^{239}Pu source after 12 minutes

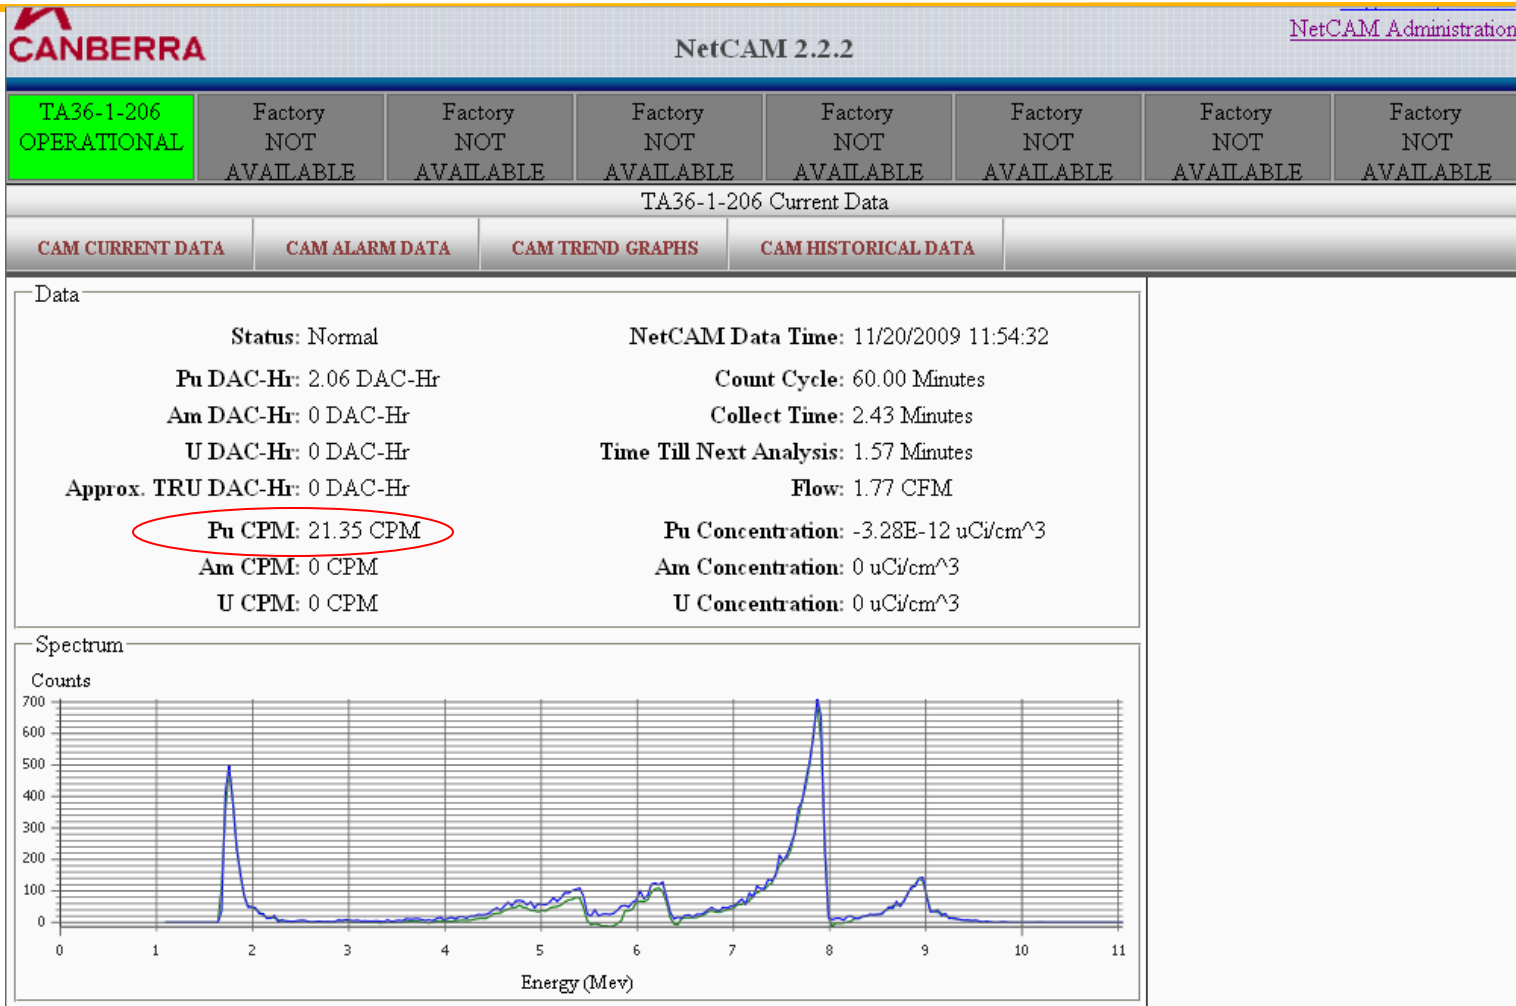
Valley mode: 75 dpm ^{239}Pu source after 60 minutes

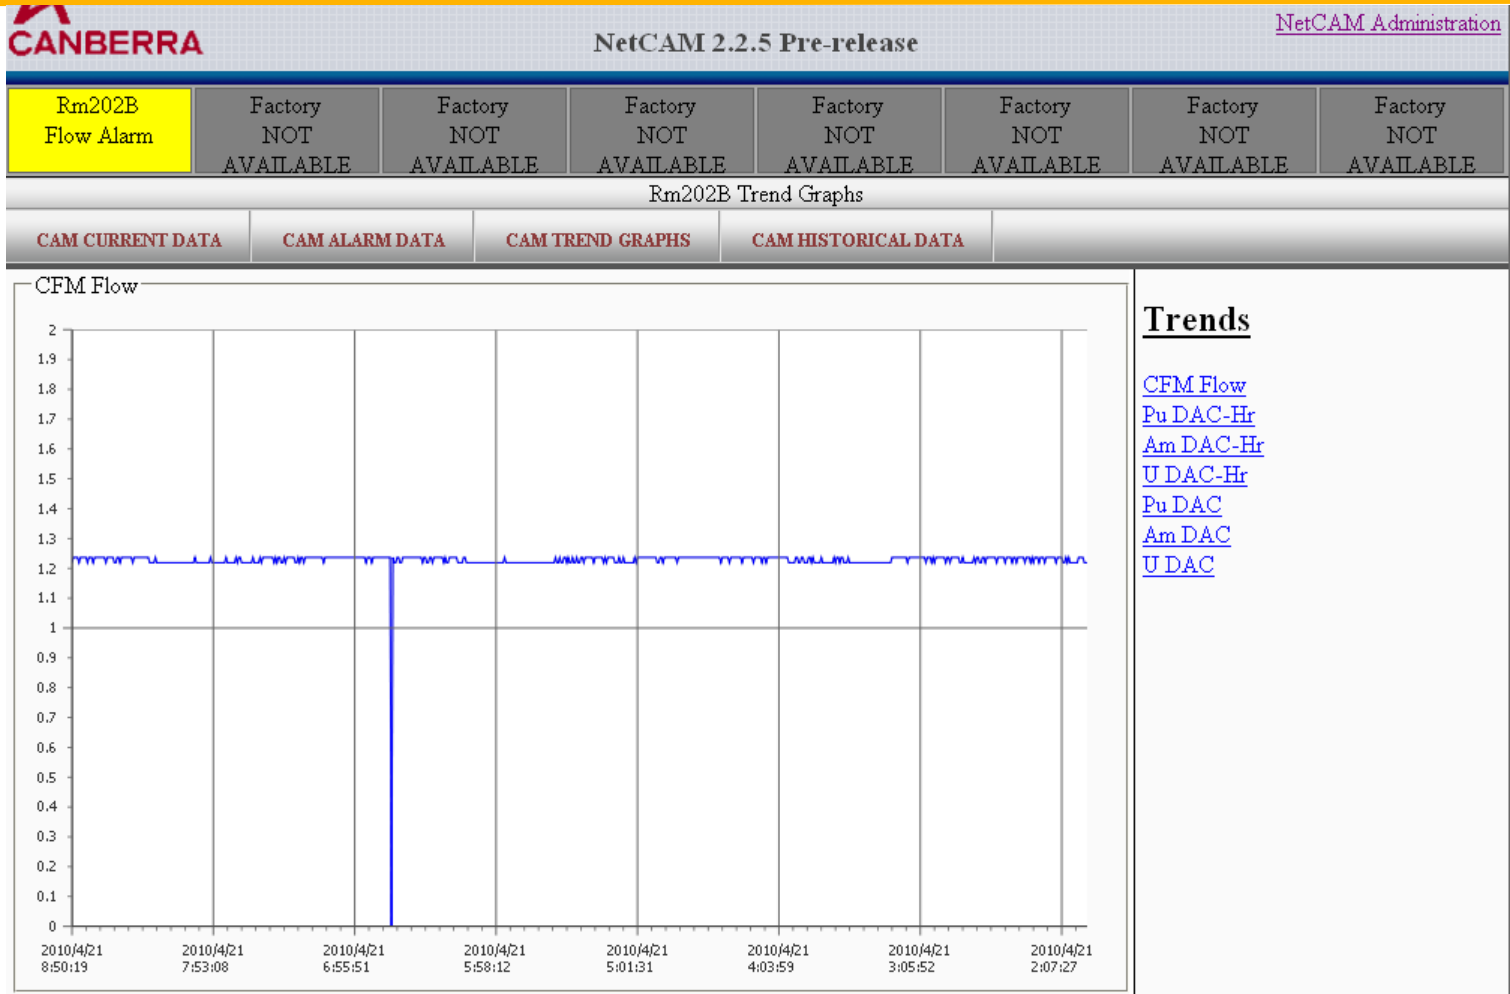
Issues to be resolved: No flow rate data

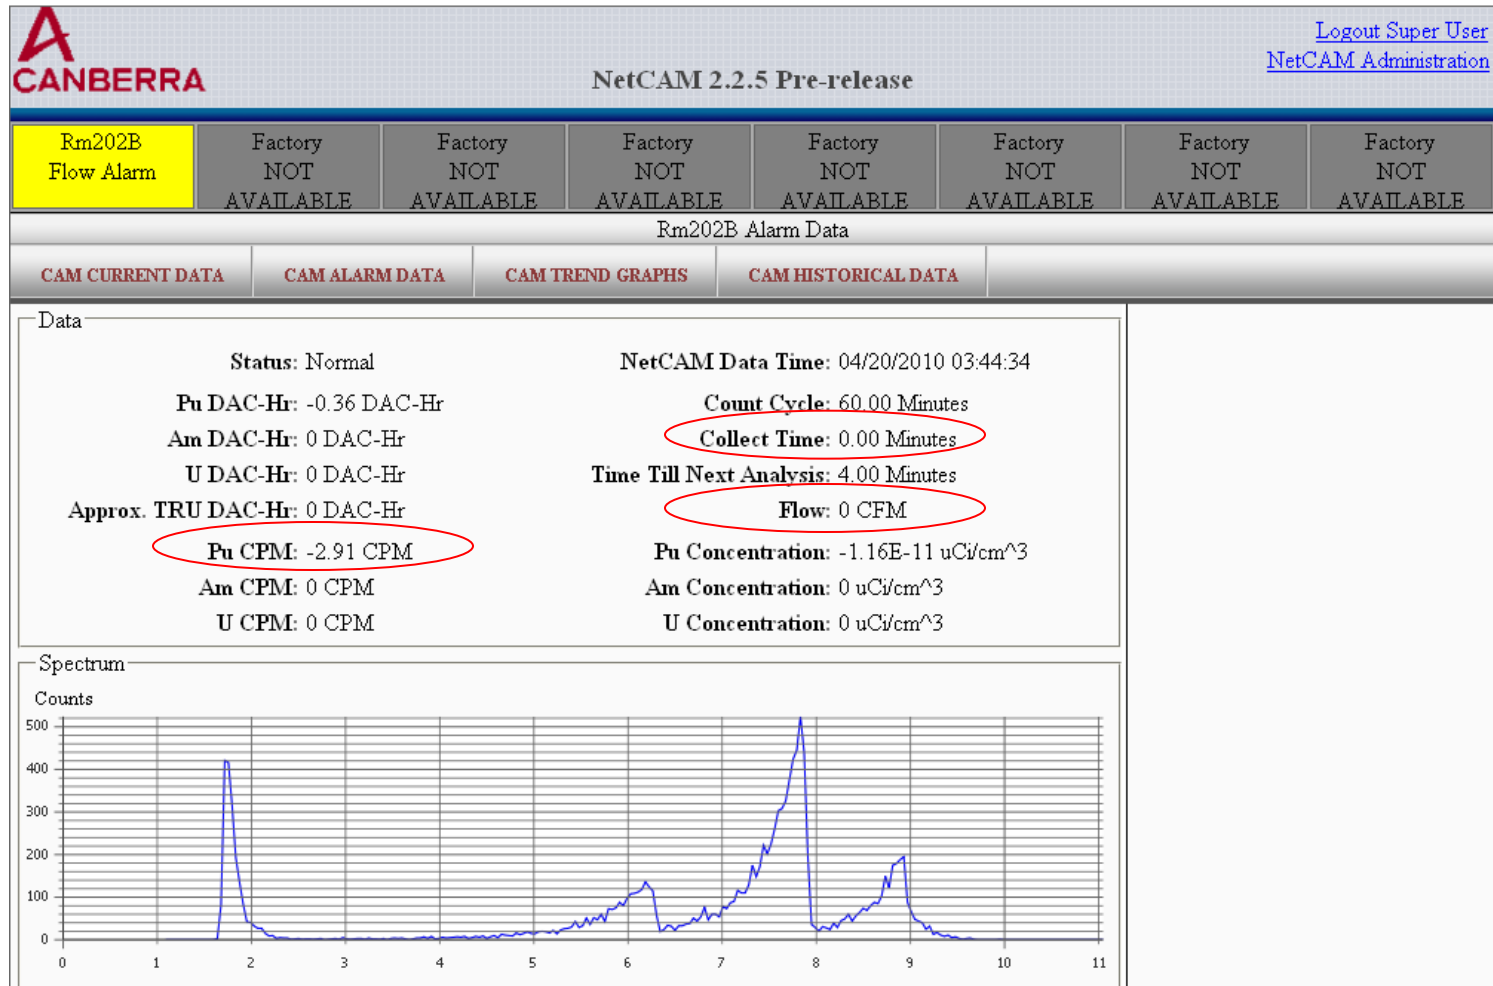
Issues to be resolved: End of cycle flow alarm message

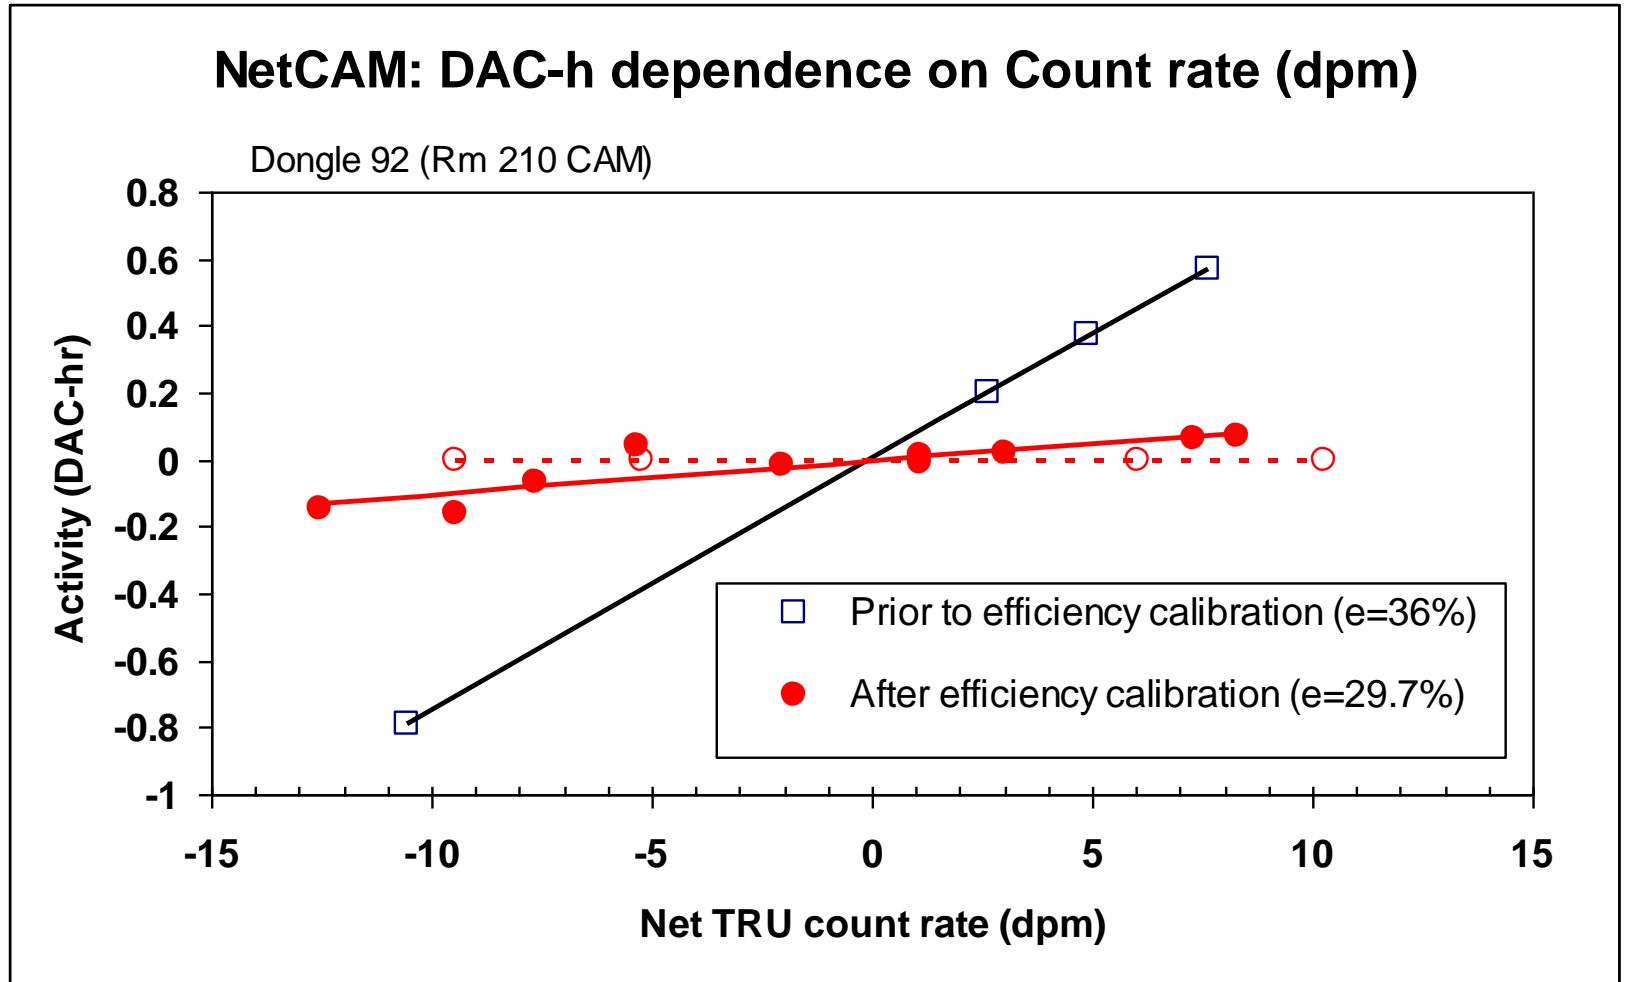
Issue: post-efficiency calibration problem

- Browser does not display efficiency
- Obvious problem in cpm → DAC-h conversion factor after a calibration

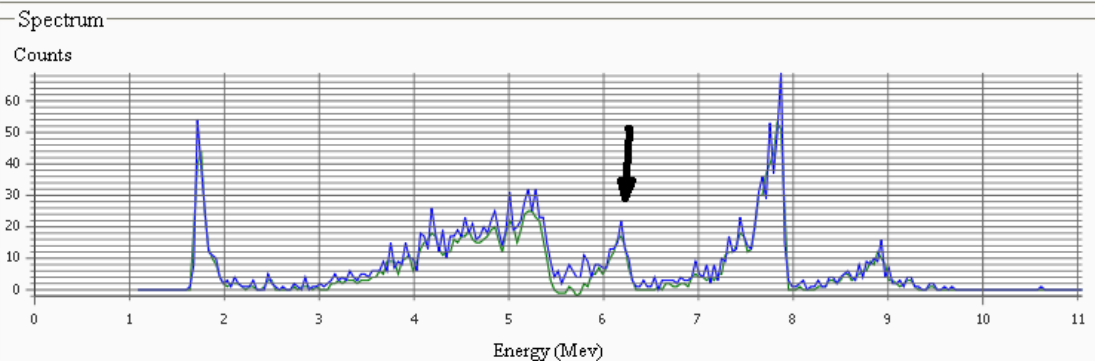
Issue: post efficiency calibration problem

Energy calibration shows chronic offset of ~ 200 keV

Expect 11 cpm ≈ 1DAC-h

- **AS1700**
 - Acute alarm operates in a differential mode
 - Possibly does not reliably update minimum count requested by user
- **Energy calibration chronically too high by 100-200 keV**
- **Valleys mode**
 - Consistently over subtracts background
 - More stable than Peaks mode
- **Peaks mode**
 - More sophisticated approach but also more prone to problems
 - Excellent Rn/Tn peak fitting – very stable.
 - Mis-identifies isotopes (probably due to energy calibration problems)
